Manhole Inspection Summary

Manhole # **S43GG_017MH**

Insp Date: **1/4/08 11:06 AM**

Location Address: **1500 HOFFMAN ST**

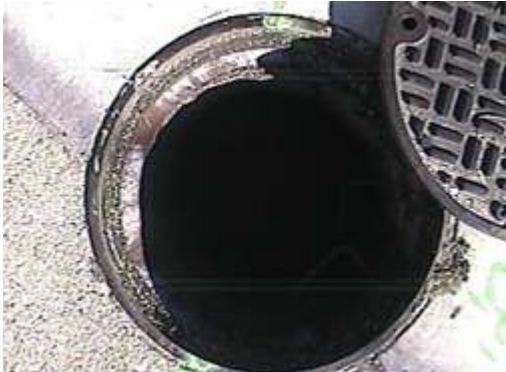
Defect 1

Frame Offset: **1** (in.) Condition: ☒ Sound ☐ Cracked ☐ Leaks

FRAME OFFSET

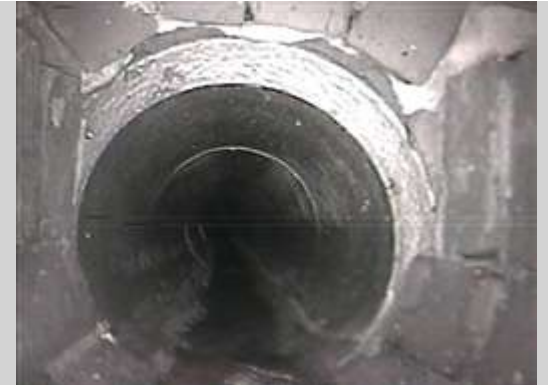
12 O'Clock Outflow

8 in. Circular Gravity Sewer
Pipe Out @ 12 O'Clock

Infiltration: **None** Pipe Seal Cond: **Sound**

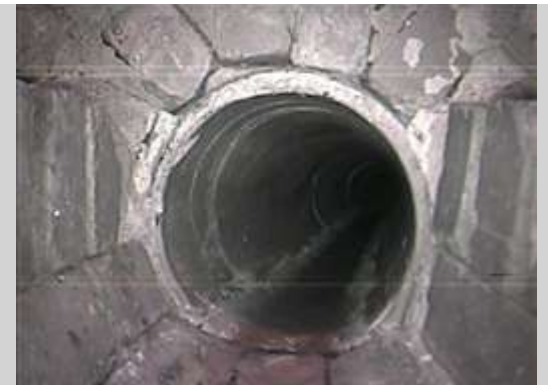
8 O'Clock Inflow

8 in. Circular Gravity Sewer
Pipe In @ 8 O'Clock

Infiltration: **None** Pipe Seal Cond: **Sound**
